Tumark[®] Vision Atlas

Case studies

Tumark® Vision – the benchmark for ultrasound visibility

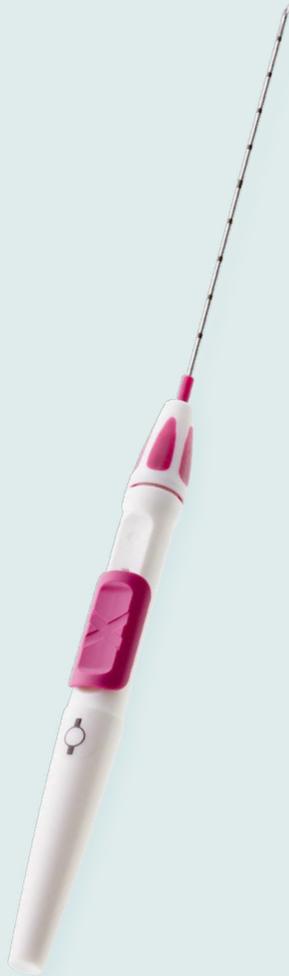
The Tumark® Vision marker is equipped with an ergonomic handle for single-handed operation.

The unique spherical shape leads to high echogenicity especially under ultrasound imaging, regardless transducer position.

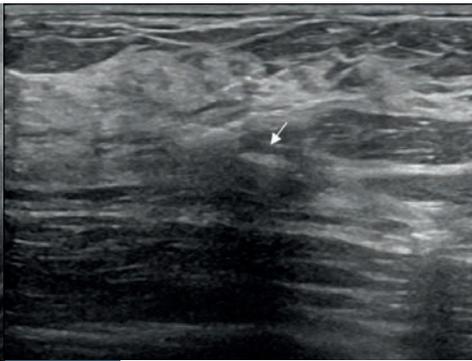
Fig. 2

Breast cancer shown as a hypoechoic lesion and the clip within (not yet expanded), directly after the procedure.

A tomosynthesis (figure 1) of a 47 year-old patient without clinical symptoms shows a lesion with surrounding architectural distortion. The ultrasound shows a correlating hypoechoic lesion. After an ultrasound-guided punch biopsy was performed (figure 2), a clip marker was positioned with Tumark Vision. Histological finding – Infiltrate of a moderately differentiated, invasive cancer of the ductal type/NST, as well as a small-lesion lobular neoplasia (LIN II). Tumor biology – Estrogen receptor: positive (100%); Progesterin receptor: positive (100%); HER2/neu: moderate expression (score 2+). FISH negative.

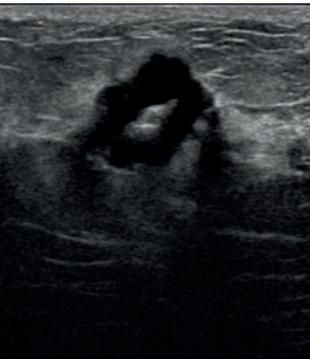
Fig. 1

Ultrasound depiction of Tumark Vision within the cancerous lesion measuring 24mm prior to the planned neoadjuvant therapy.

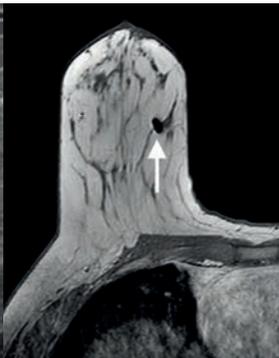
Fig. 5

MRI axial T1-w of the right breast shows the susceptibility artifact inside due to the clip (Tumark Vision), indicated by the arrow.

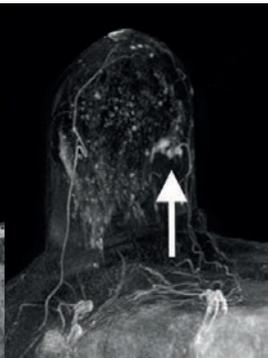
Fig. 6

MRI as axial maximum intensity projection (MIP) of the first subtraction. Prior to PST with the occult primary tumor inside-right up to this point, is indicated by the arrow.
